## **Airfield Pavement Condition Survey, Sabre Army Heliport, Fort Campbell, Kentucky**

March 2002

## **Final report**

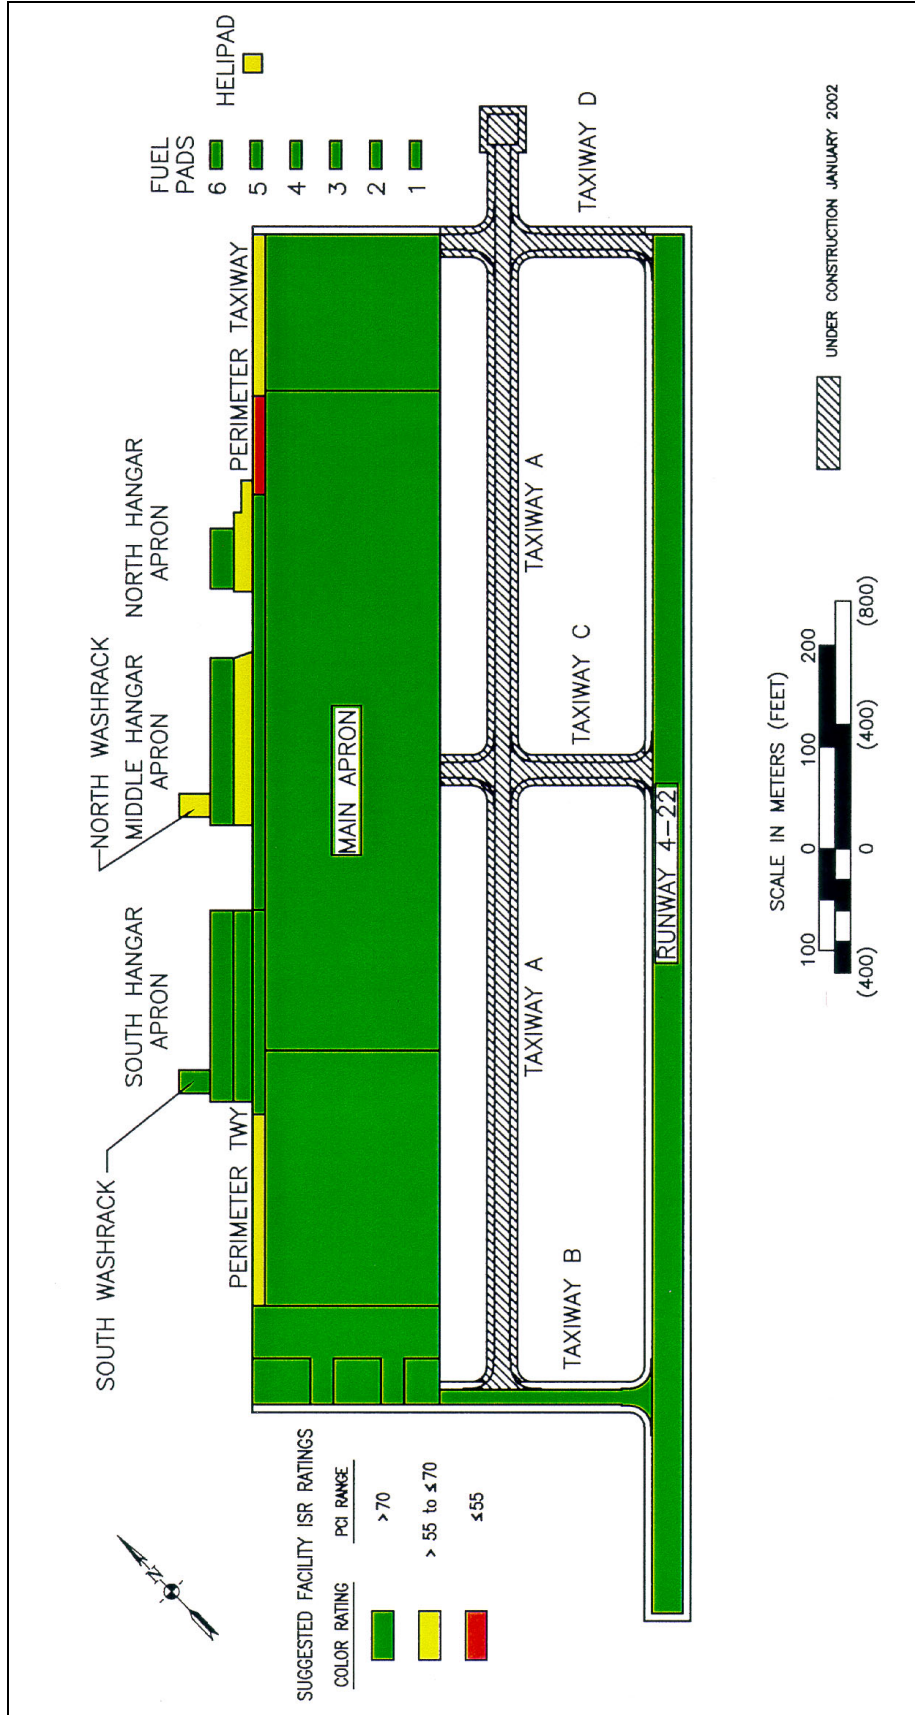
Illustration 1. Airfield pavement ISR ratings

- b.* The PCI's of features T8B and T9B failed to meet the minimum acceptable level.
- c.* Installation Status Report (ISR) ratings for the airfield are shown in Illustration 1.

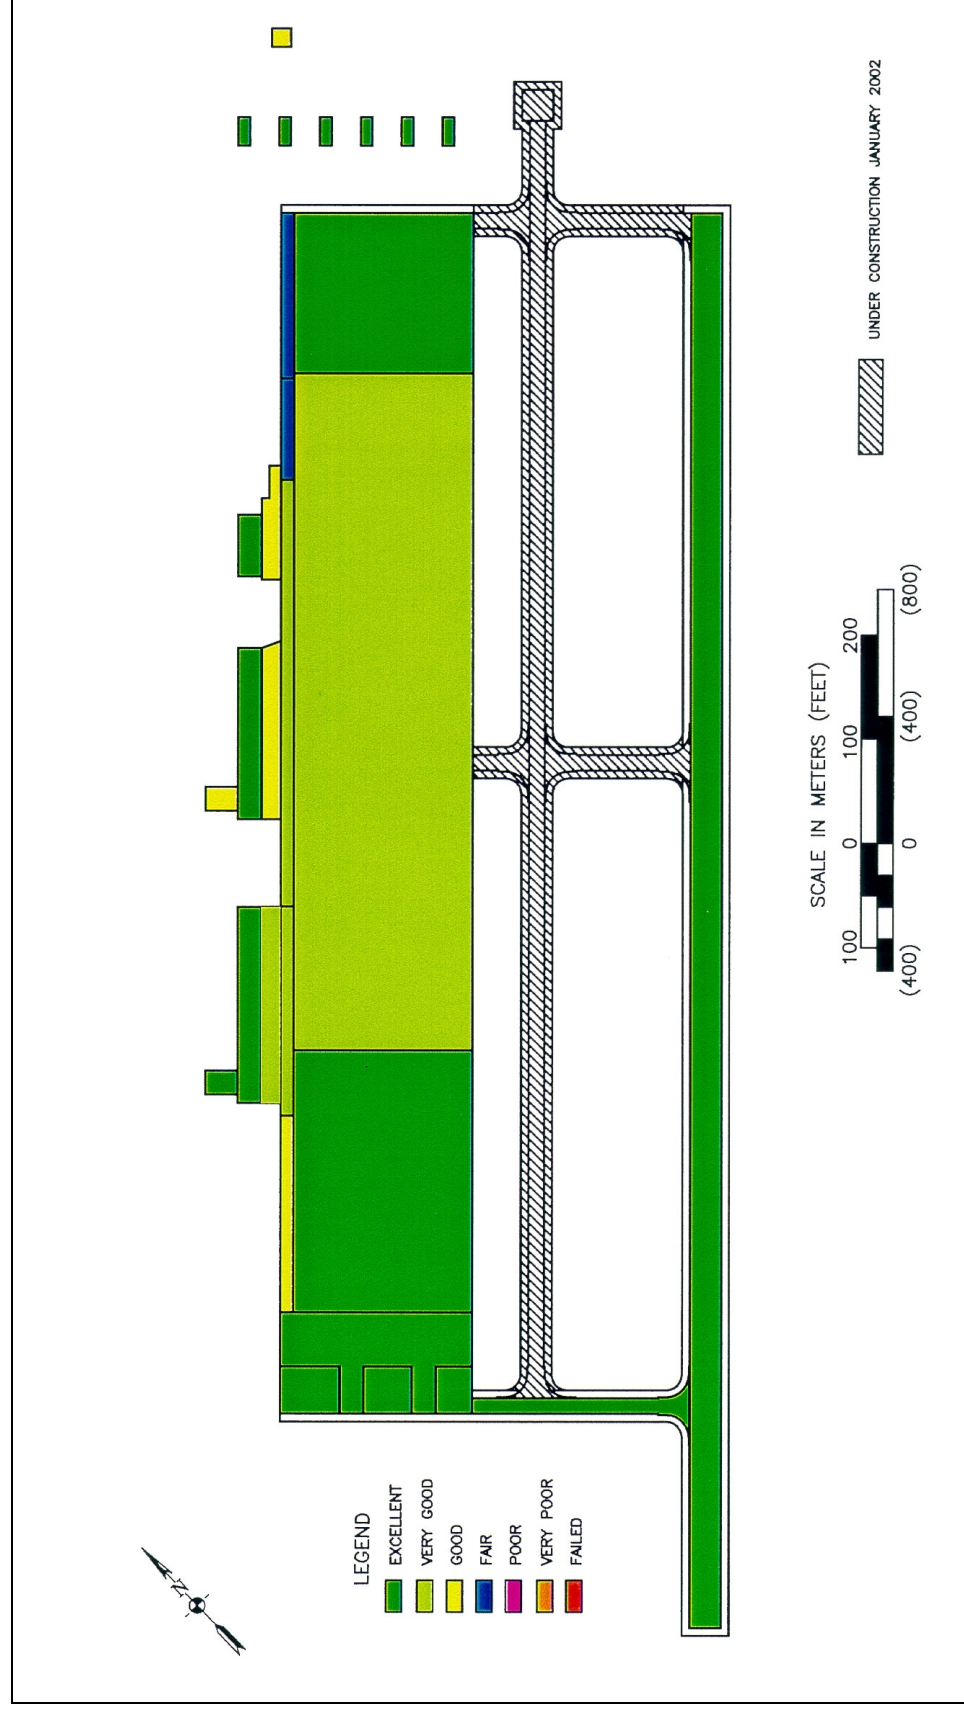
Figure 11. Pavement condition rating summary

The PCI for each sample unit inspected was calculated and stored on a Micro PAVER file for SAHP. The mean PCI for each feature was then calculated to determine the general condition or rating of the feature as shown in Figure 11. A comparison of the 2001, and 1996 PCI results is summarized in Table 4. The PCI of five of the airfield features decreased from one to thirteen points during the 1996 to 2001 period. This loss in PCI points is considered normal (4 to 6 points per year). The PCI of eight of the airfield features increased from two to nine during the 1996 to 2001 period. The increase in PCI of seventeen to twenty points on the South Hangar Apron (A7B) and Perimeter taxiway (T6B) was due to a seal coat applied after the 1996 survey.

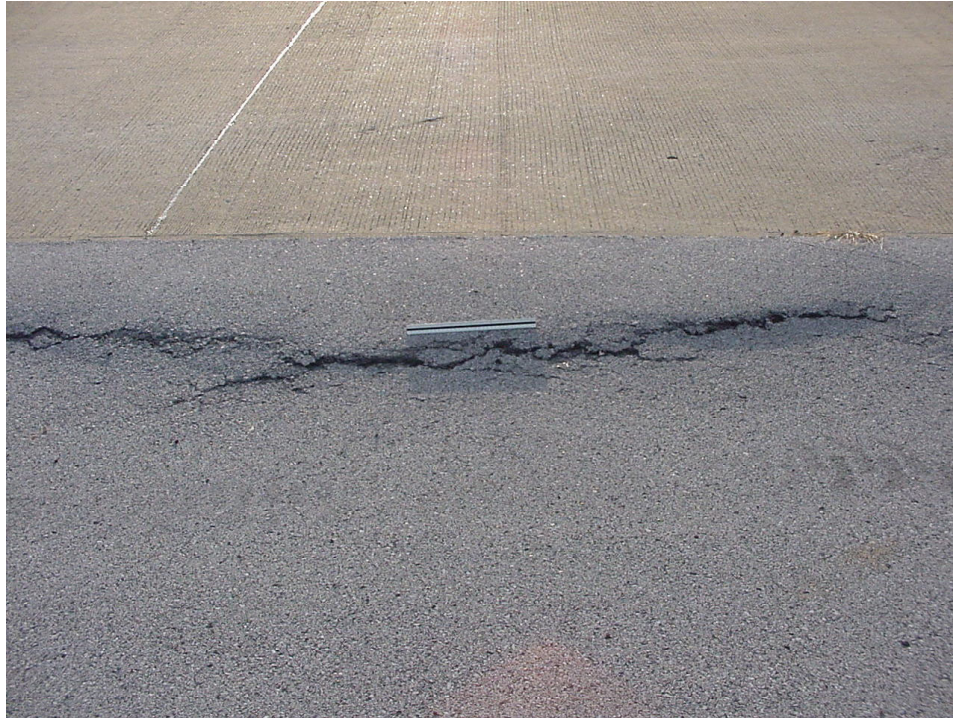
Photo 1. Perimeter Taxiway, Feature T5B, medium-severity shoving

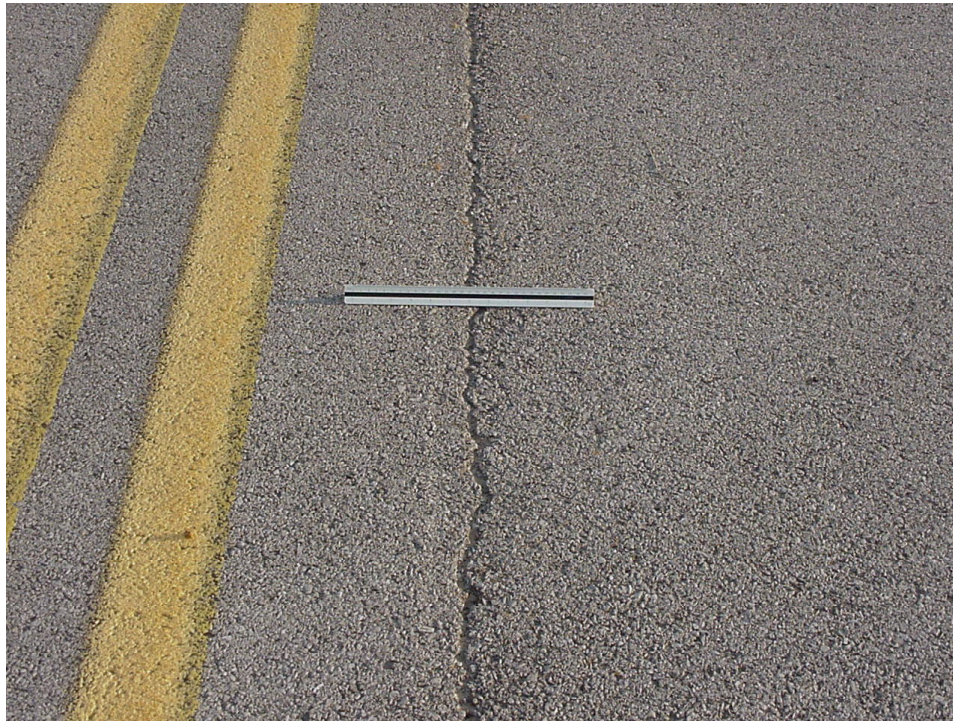
Photo 2. Perimeter Taxiway, Feature T5B, medium-severity longitudinal crack

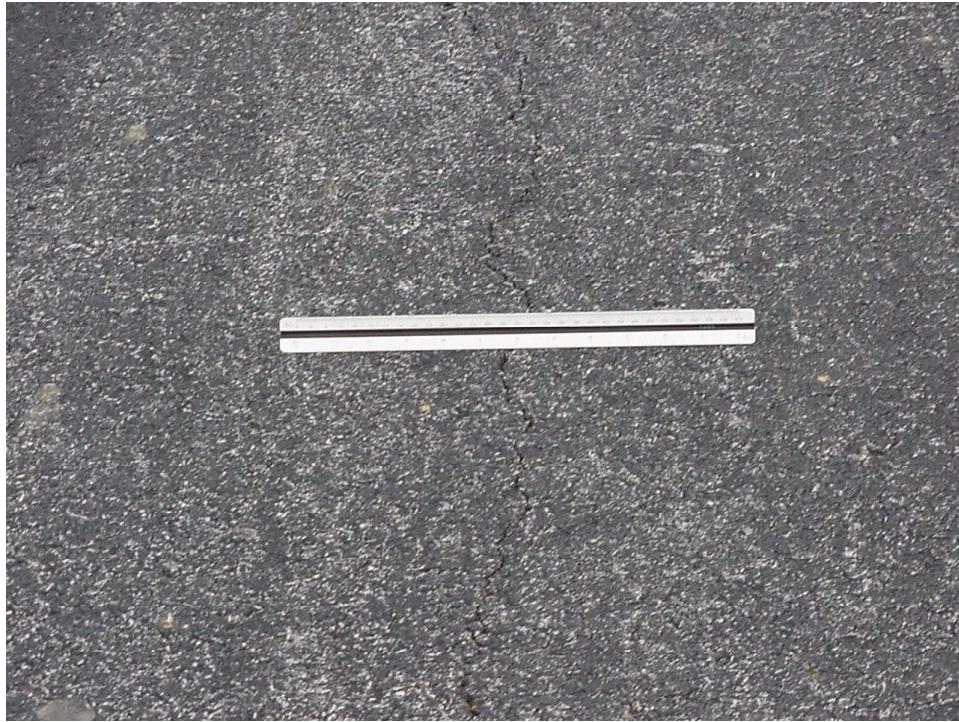
Photo 3. Perimeter Taxiway, Feature T6B, low-severity longitudinal crack

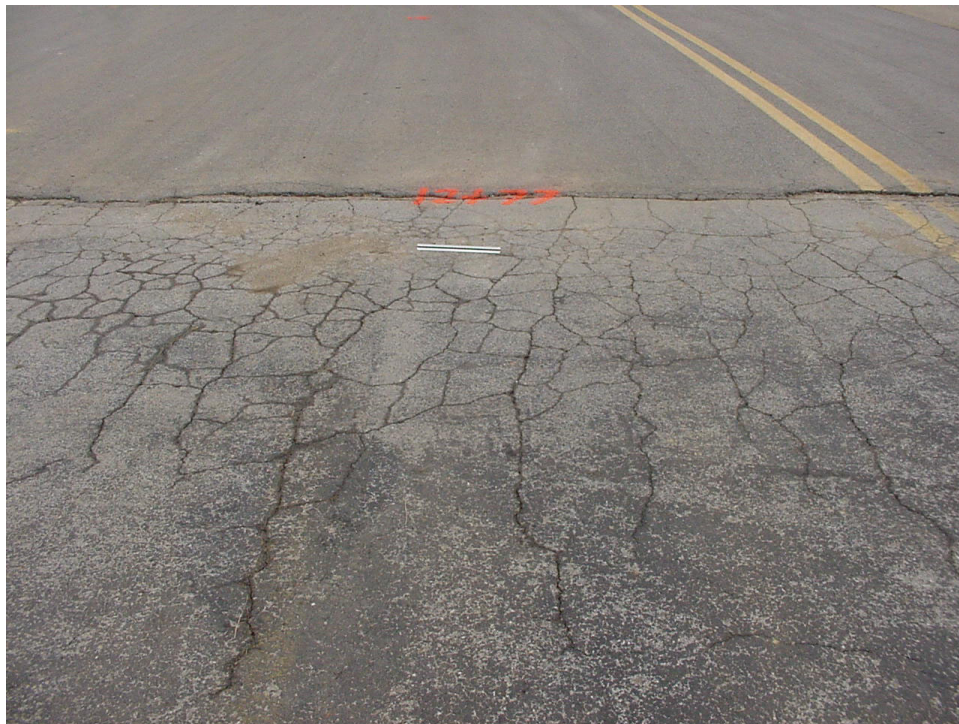
- d.* Approximately \$12,150 (FY02) for repair is required to improve the surfaces of features T8B and T9B to meet the minimum PCI requirements. This also includes repair to an isolated area of alligator cracking (Photo 4) at the intersection of features T6B and T7B (sta 12+77).

Photo 4. Perimeter Taxiway, Feature T6B, high-severity alligator cracking

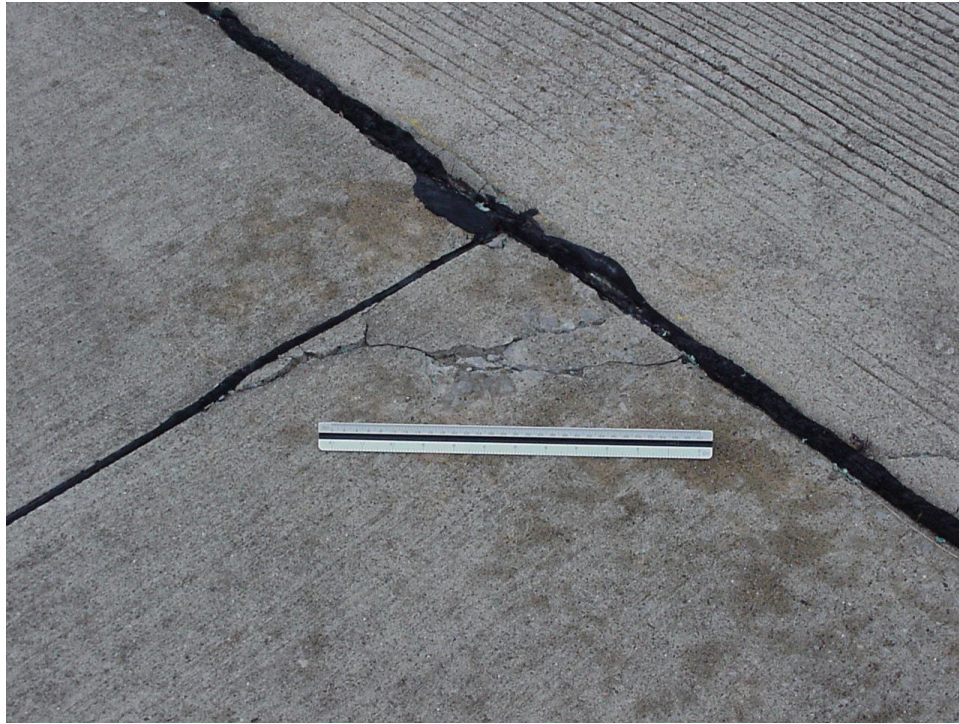
Photo 5. Main Apron, Feature A2B, medium-severity corner spall

<b>Table 8 (Continued)</b>		
<b>Feature</b>	<b>AreaSq m (sq yd)</b>	<b>Maintenance and Repair Alternatives for Existing Surfaces</b>
<b>Main Apron</b>		
A1B	6299 (7,533)	None
A2B	11 539 (13,800)	The PCI of this feature is above that required for aprons. However, it is recommended that all low- and medium-severity cracks be cleaned and sealed with a high-quality sealer <sup>3</sup> , and repair all low- medium- and high-severity spalls with an epoxy concrete patch or full-depth patching (see the PCASE on-line FACT SHEET web site for product guidance).
A3B	42 924 (51,333)	The PCI of this feature is above that required for aprons. However, it is recommended that all medium- and high-severity spalls be repaired with an epoxy concrete patch or full-depth patching.
A4B	110 822 (132,533)	The PCI of this feature is above that required for aprons. However, it is recommended that all medium-severity cracks be cleaned and sealed with a high-quality sealer <sup>2</sup> , repair all medium- and high-severity spalls and durability cracking with an epoxy concrete patch or full-depth patching, and remove and replace the joint sealant with a high-quality sealer <sup>2</sup> (see the PCASE on-line FACT SHEET web site for product guidance).

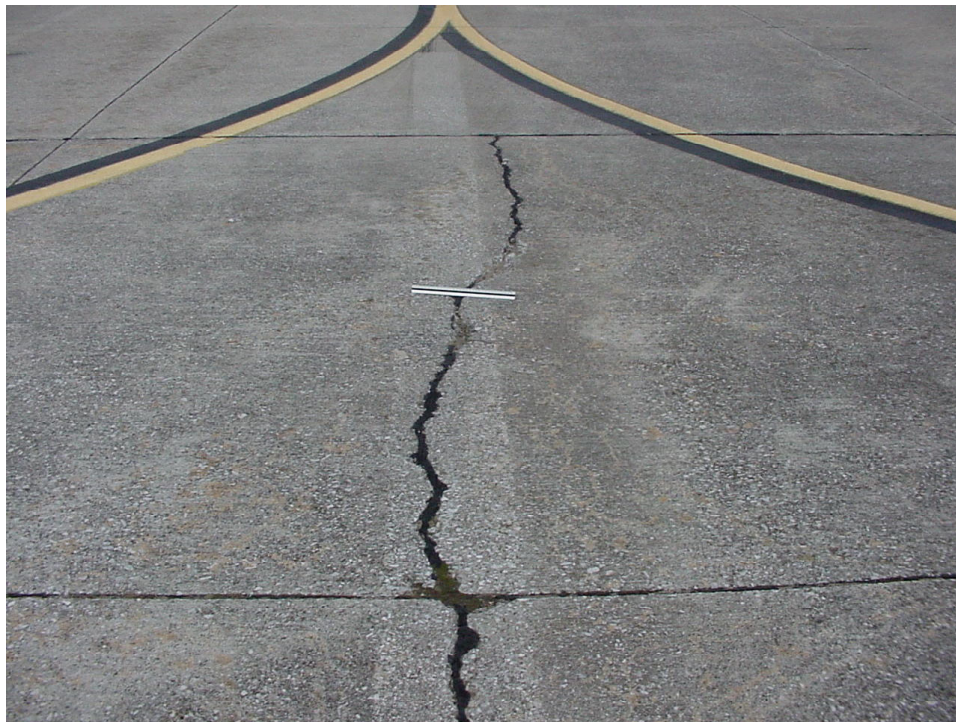
Photo 6. Main Apron, Feature A4B, medium-severity longitudinal crack

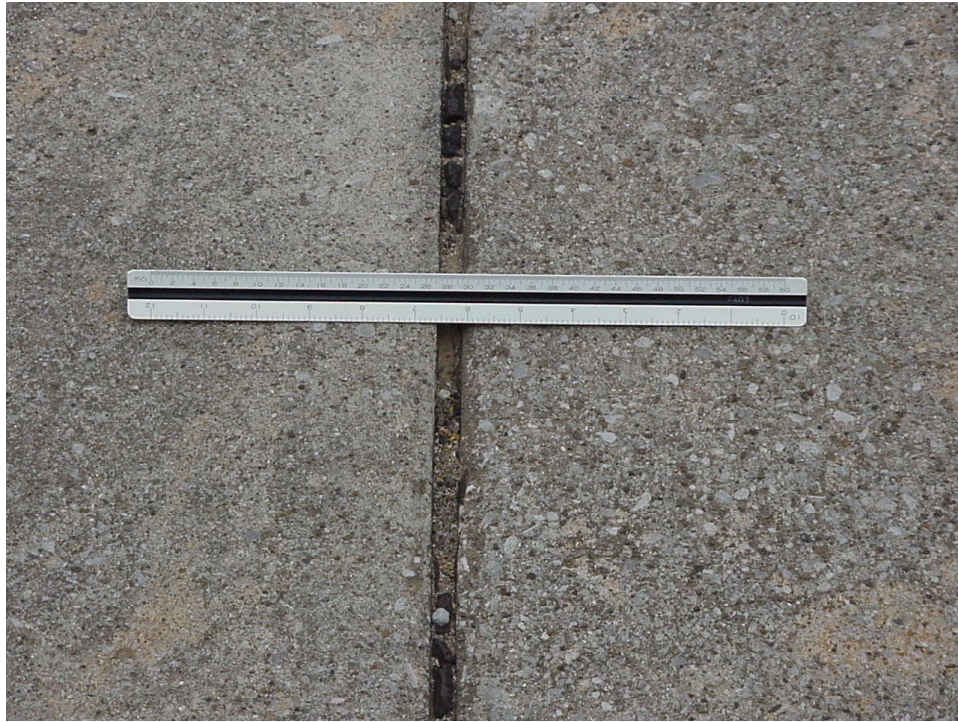
Photo 7. Main Apron, Feature A4B, high-severity joint sealant damage

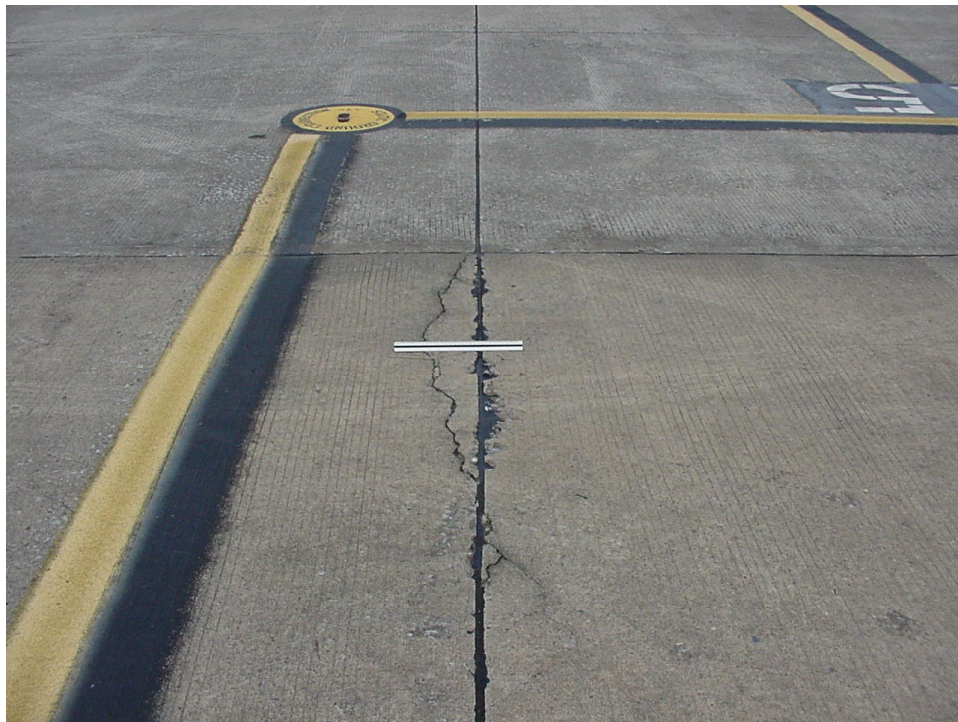
Photo 8. Main Apron, Feature A5B, medium-severity joint spall

A5B	26 534 (31,733)	The PCI of this feature is above that required for aprons. However, it is recommended that all low- and medium-severity cracks be cleaned and sealed with a high-quality sealer <sup>2</sup> , and repair all low- and medium- severity spalls with an epoxy concrete patch or full-depth patching (see the PCASE on-line FACT SHEET web site for product guidance).
<b>South Hangar Apron</b>		
A6B	4285 (5,125)	Same as for A5B.
A7B	3428 (4,100)	The PCI of this feature is above that required for aprons. However, it is recommended that all cracks are cleaned and sealed with a high-quality crack sealant <sup>2</sup> (see the PCASE on-line FACT SHEET web site for product guidance).
<b>South Washrack</b>		
A8B	697 (833)	None.
<b>Middle Hangar Apron</b>		
A9B	3763 (4,500)	The PCI of this feature is above that required for aprons. However, it is recommended that all low- and medium-severity spalls be repaired with an epoxy concrete patch or full-depth patching, and remove and replace the joint sealant with a high-quality sealer <sup>2</sup> (see the PCASE on-line FACT SHEET web site for product guidance).

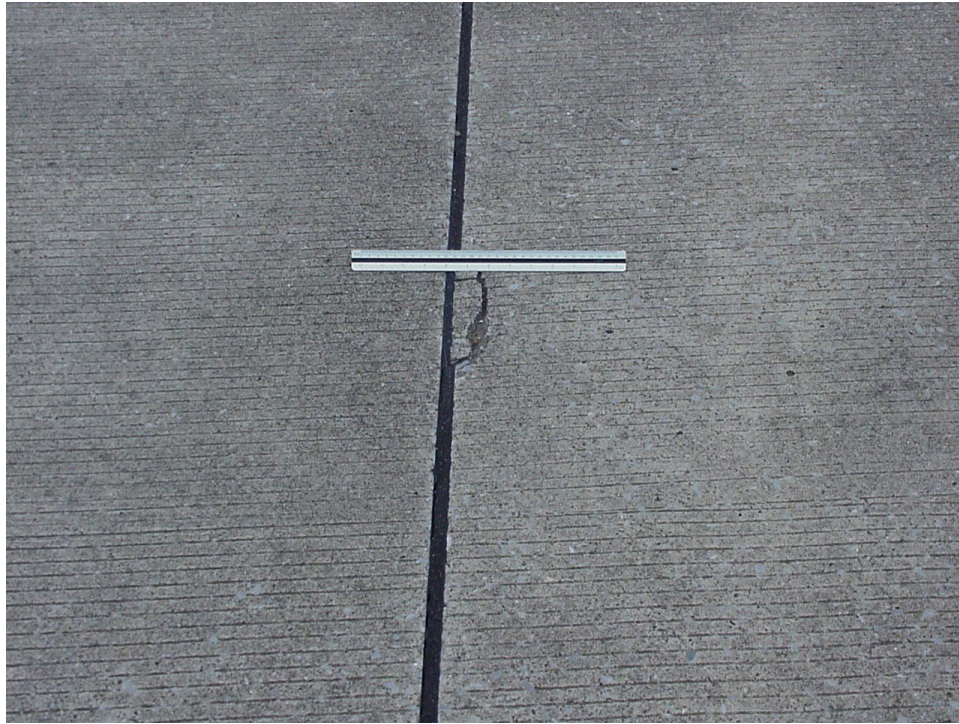
Photo 9. Main Apron, Feature A5B, low-severity joint spall

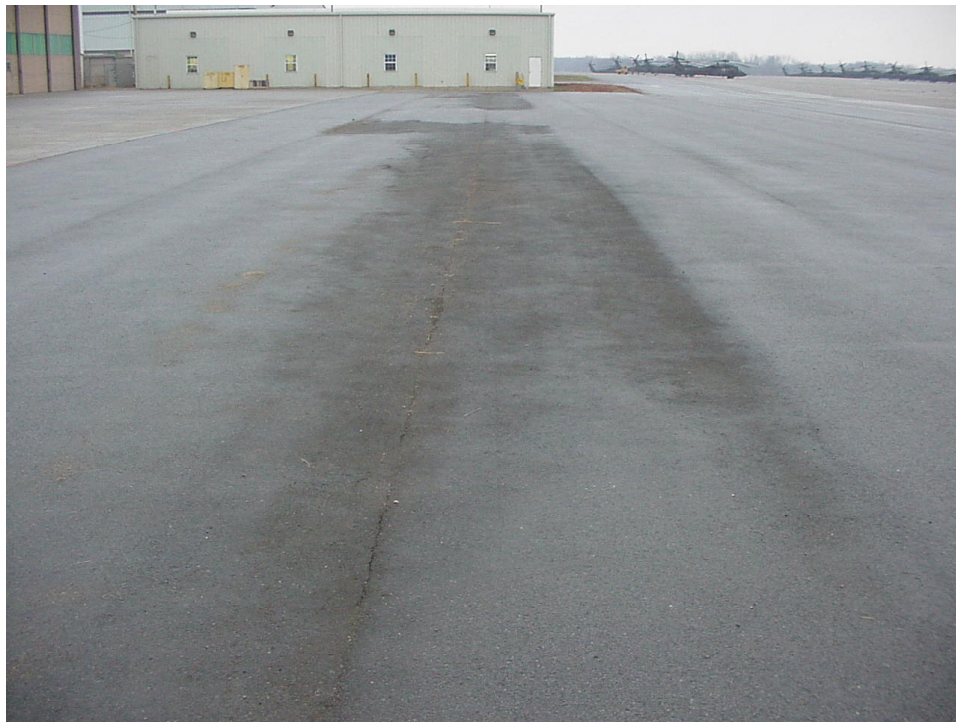
Photo 10. Middle Hangar Apron, Feature A10B, depression

A10B	3072 (3,673)	The PCI of this feature is above that required for aprons. However, it is recommended that all cracks be cleaned and sealed with a high-quality crack sealant <sup>2</sup> , and repair low-severity depressions with a partial depth patch (see the PCASE on-line FACT SHEET web site for product guidance).
<b>North Washrack</b>		
A11B	697 (833)	The PCI of this feature is above that required for aprons. However, it is recommended that all low- and medium-severity cracks be cleaned and sealed with a high-quality sealer <sup>2</sup> and remove and replace the joint sealant with a high-quality sealer <sup>2</sup> (see the PCASE on-line FACT SHEET web site for product guidance).
<b>(Sheet 2 of 3)</b>		
<sup>1</sup> For planning purposes only.		
<sup>2</sup> See TM 5-882-11/AFP 88-6, Chapter 7 (Headquarters, Departments of the Army and Air Force 1993) for guidance.
